MECHANICAL REPORT MAZDA CX5 KDN 354K

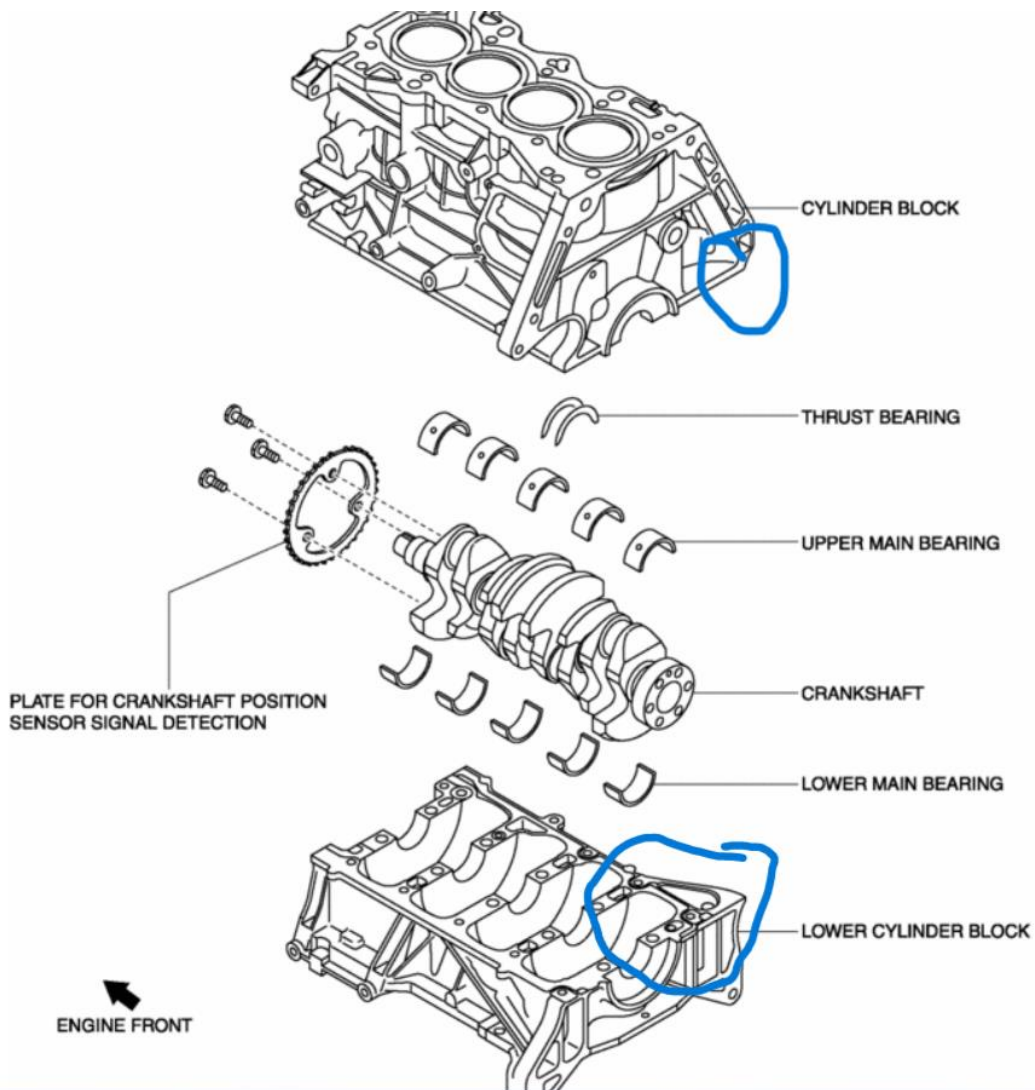
The aforementioned vehicle vin **(KF2P-321826)** was brought to the Service Centre with an issue of oil leaks underneath it. Upon a thorough inspection, it was established that the source of the leak was from the mating surfaces of the cylinder block and the lower cylinder block on the rear of the engine as highlighted on the extract images below.

The remedy entails removal of the engine from the engine bay, dismantling of the engine oil sump to gain access to the lower cylinder block which has to be detached from the cylinder block

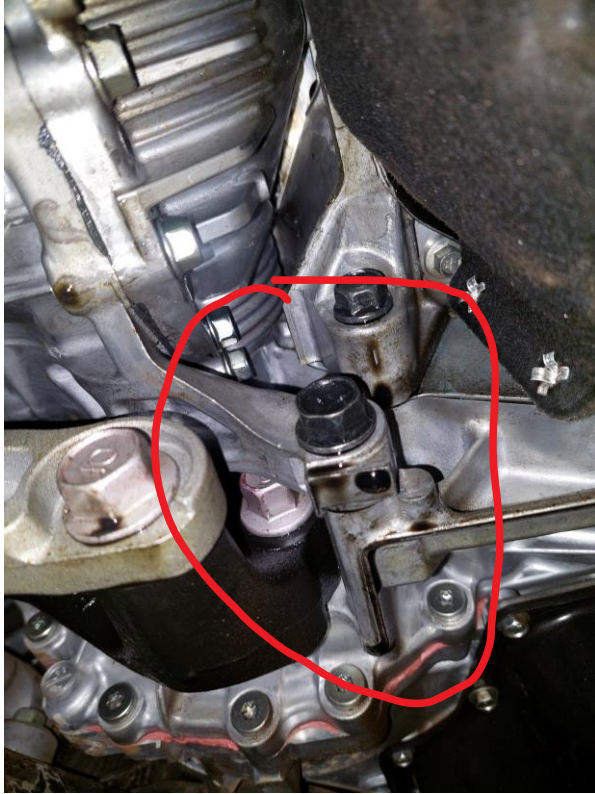
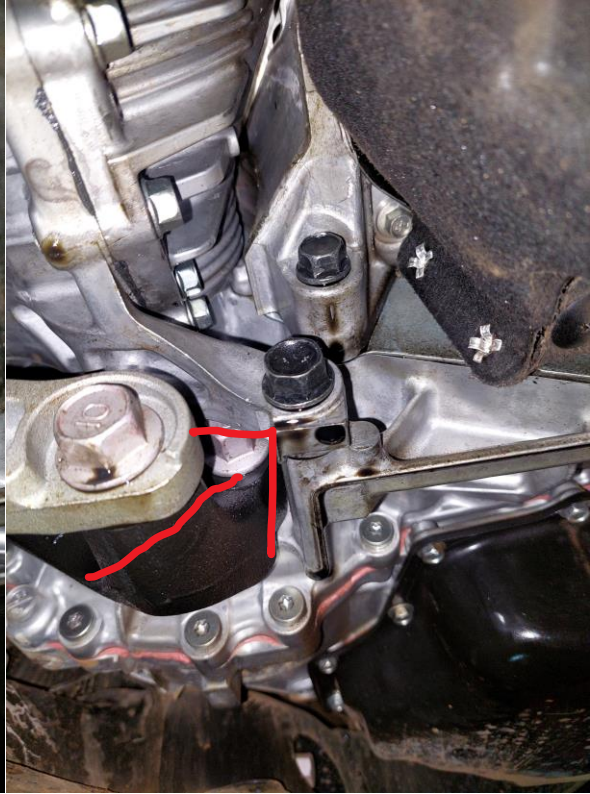
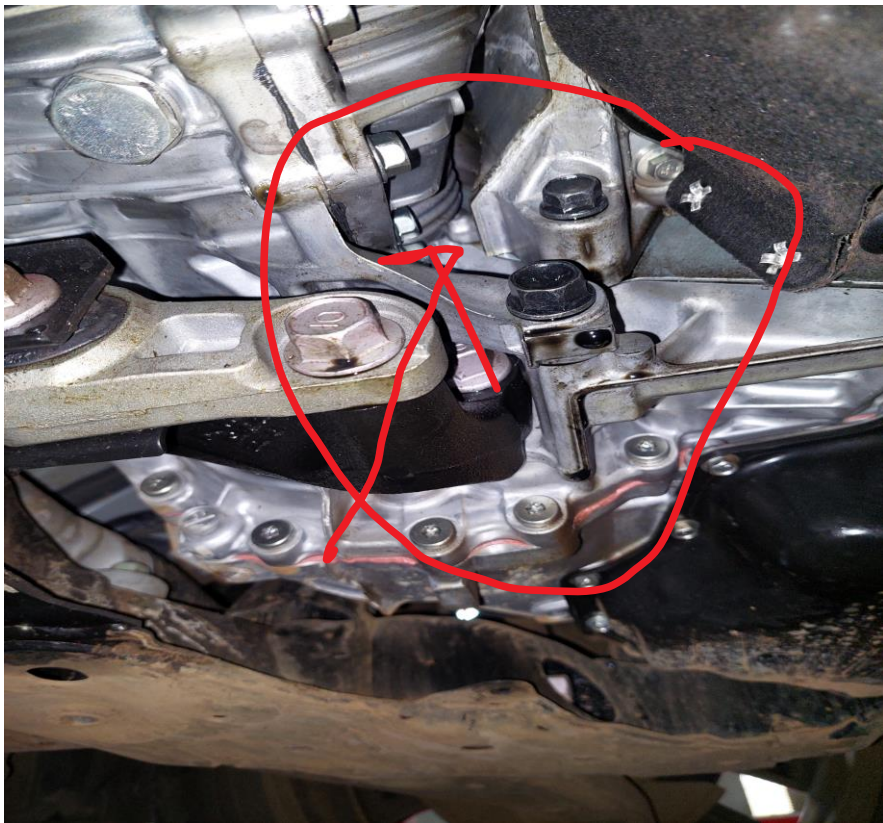
Actual images of the leakages as attached below.
